Manhole Inspection Summary

Manhole # S45II_059MH

Location Address: **Chester St**

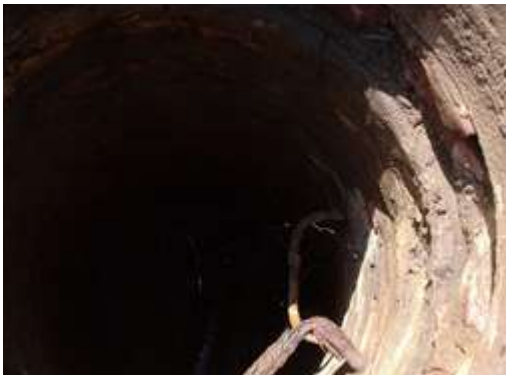
Defect 2

Infiltration: ☐ None ☐ Joint ☐ Cracks ☐ Mortar ☐ Roots ☒ **Wall**

Infiltration

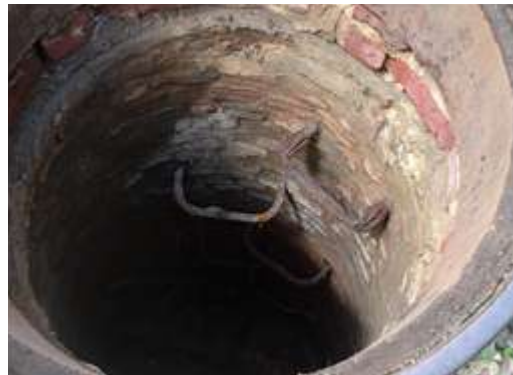
Defect 1

Condition: ☐ Sound ☐ Cracked ☐ Root Intrusion ☒ **Loose Brick** ☐ Deteriorated

Infiltration: ☐ None ☐ Joint ☐ Cracks ☒ **Mortar** ☐ Roots ☐ Wall

Loose Bricks

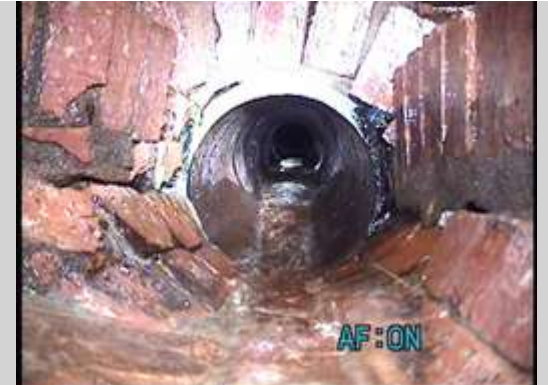
12 O'Clock Outflow

8 in. Circular Gravity Sewer
Pipe Out @ 12 O'Clock

Pipe Height: **8.4** (in.) Rod and Bar (Angled)
Pipe Material: **Clay** ☐ Pipe Lined
Invert Depth: **11.10** (ft.) Flow Characteristics: **Slow**
Deposits: ☒ None ☐ Mud ☐ Sludge ☐ Debris ☐ Grease
Silt Depth: (in.) Deposits Extent:
Infiltration: **None** Pipe Seal Cond: **Sound**

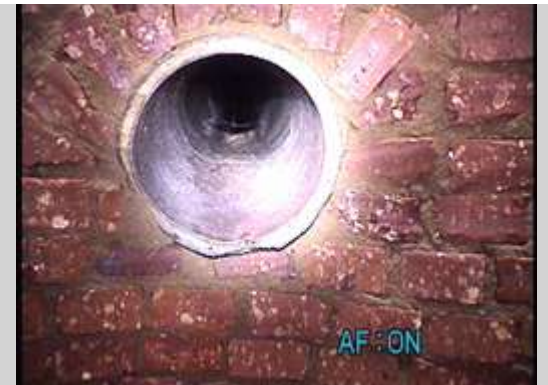
6 O'Clock Inflow

8 in. Circular Gravity Sewer
Pipe In @ 6 O'Clock

Drop In @ 6 O'Clock

Pipe Height: **8.4** (in.) Rod and Bar (Angled)
Pipe Material: **Clay** ☐ Pipe Lined
Invert Depth: **8.50** (ft.) Flow Characteristics: **Slow**
Deposits: ☒ None ☐ Mud ☐ Sludge ☐ Debris ☐ Grease
Silt Depth: (in.) Deposits Extent:
Infiltration: **None** Pipe Seal Cond: **Sound**

Drop: **Inside** Rod and Bar
Angled: **Yes** Reading: **9.65** (ft.)
Inv Depth: **10.65** (ft.)

Drop Condition: **Open**

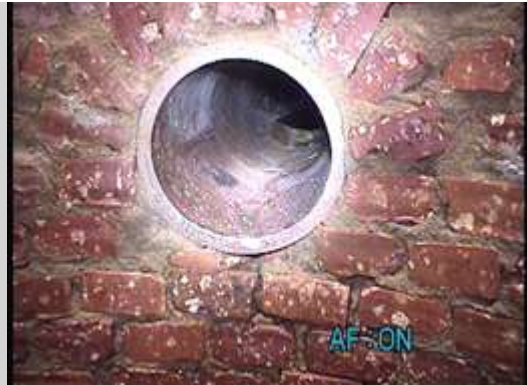
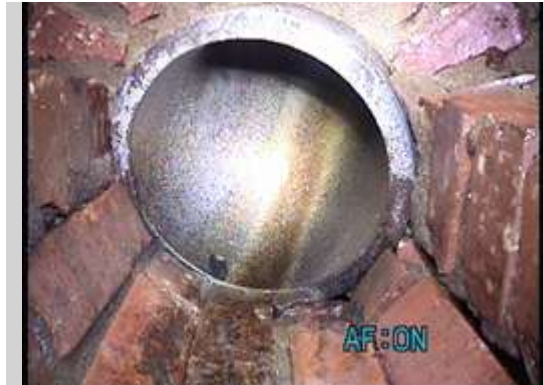
9 O'Clock Inflow

6 in. Circular Gravity Sewer

Pipe In @ 9 O'Clock

Drop In @ 9 O'Clock

Infiltration: **None** Pipe Seal Cond: **Sound**

Drop: **Inside**

Drop Condition: **Open**
